# Asset Management

Most wells eventually lose capacity and experience lower pumping water levels, resulting in increased pumping costs. Implementing a time-based maintenance program can avoid potential problems. Ongoing performance monitoring can signal when it's time for rehabilitation to maintain or restore performance. **BY RAY REECE, BILL PREHODA, AND RANDY MOORE**

# MAINTENANCE WELL ASSET MANAGEMENT INCREASES SERVICE LIFE

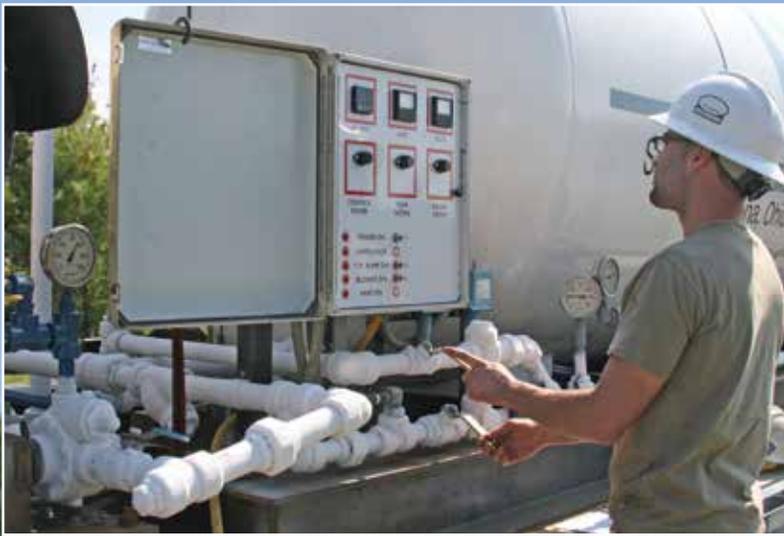
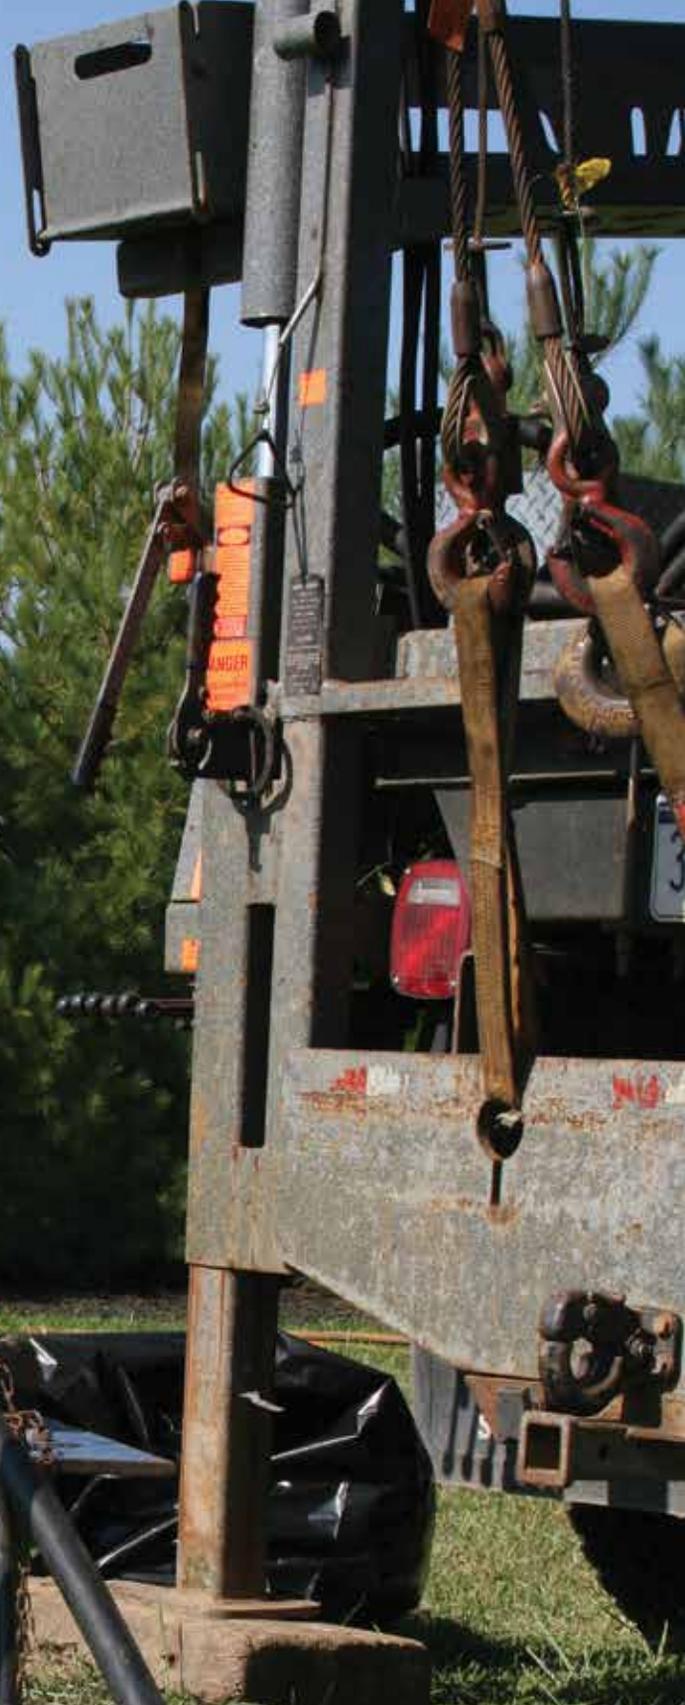
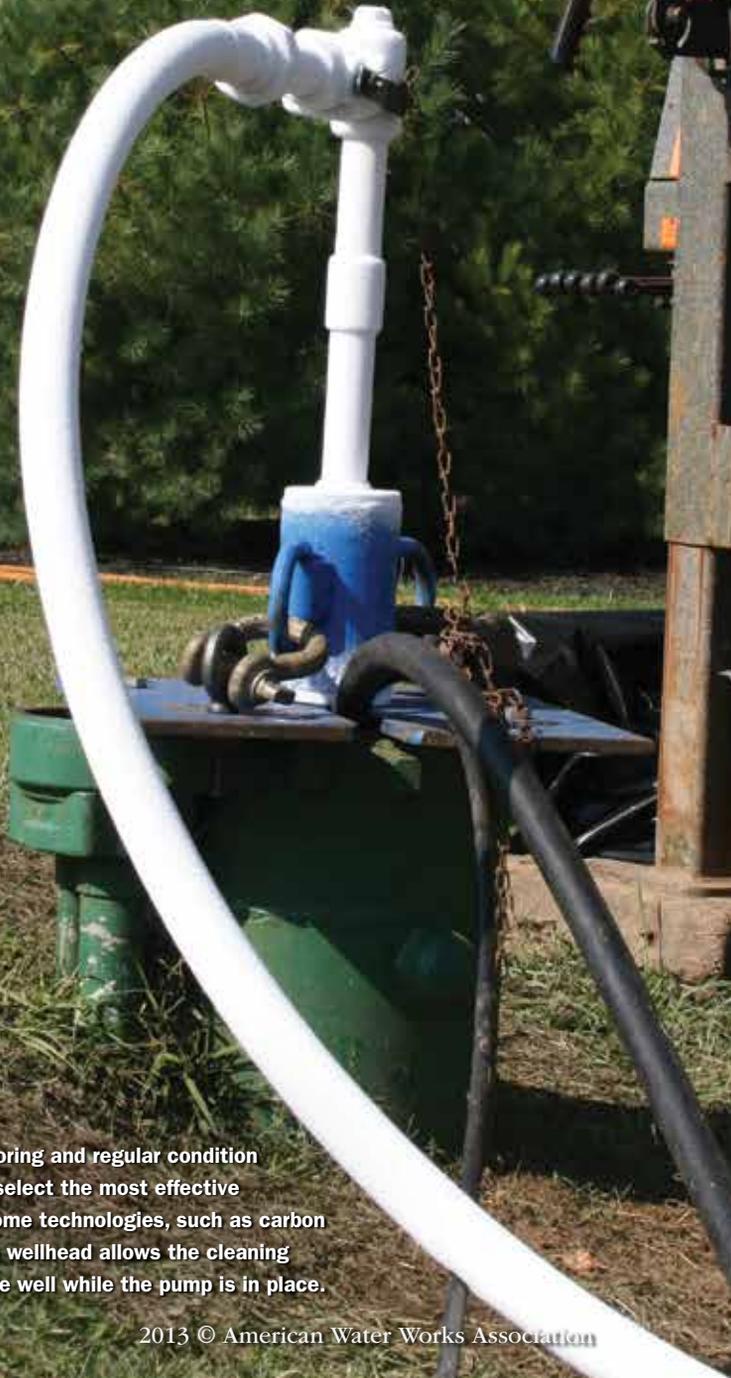
Effective well performance monitoring and regular condition assessments allow personnel to select the most effective rehabilitation technology. With some technologies, such as carbon dioxide, hardware installed at the wellhead allows the cleaning technology to be installed into the well while the pump is in place.

With certain well rehabilitation technologies, such as carbon dioxide, hardware installed at the wellhead allows the cleaning technology to be installed into the well while the pump is in place. When the hardware is installed, mini-cleanings can be performed per a
